# **2002 Annual Compliance Report Converse County (Spook), Wyoming, Disposal Site**

Figure 18–1. 2002 Annual Compliance Drawing for the Spook, Wyoming, Disposal Site

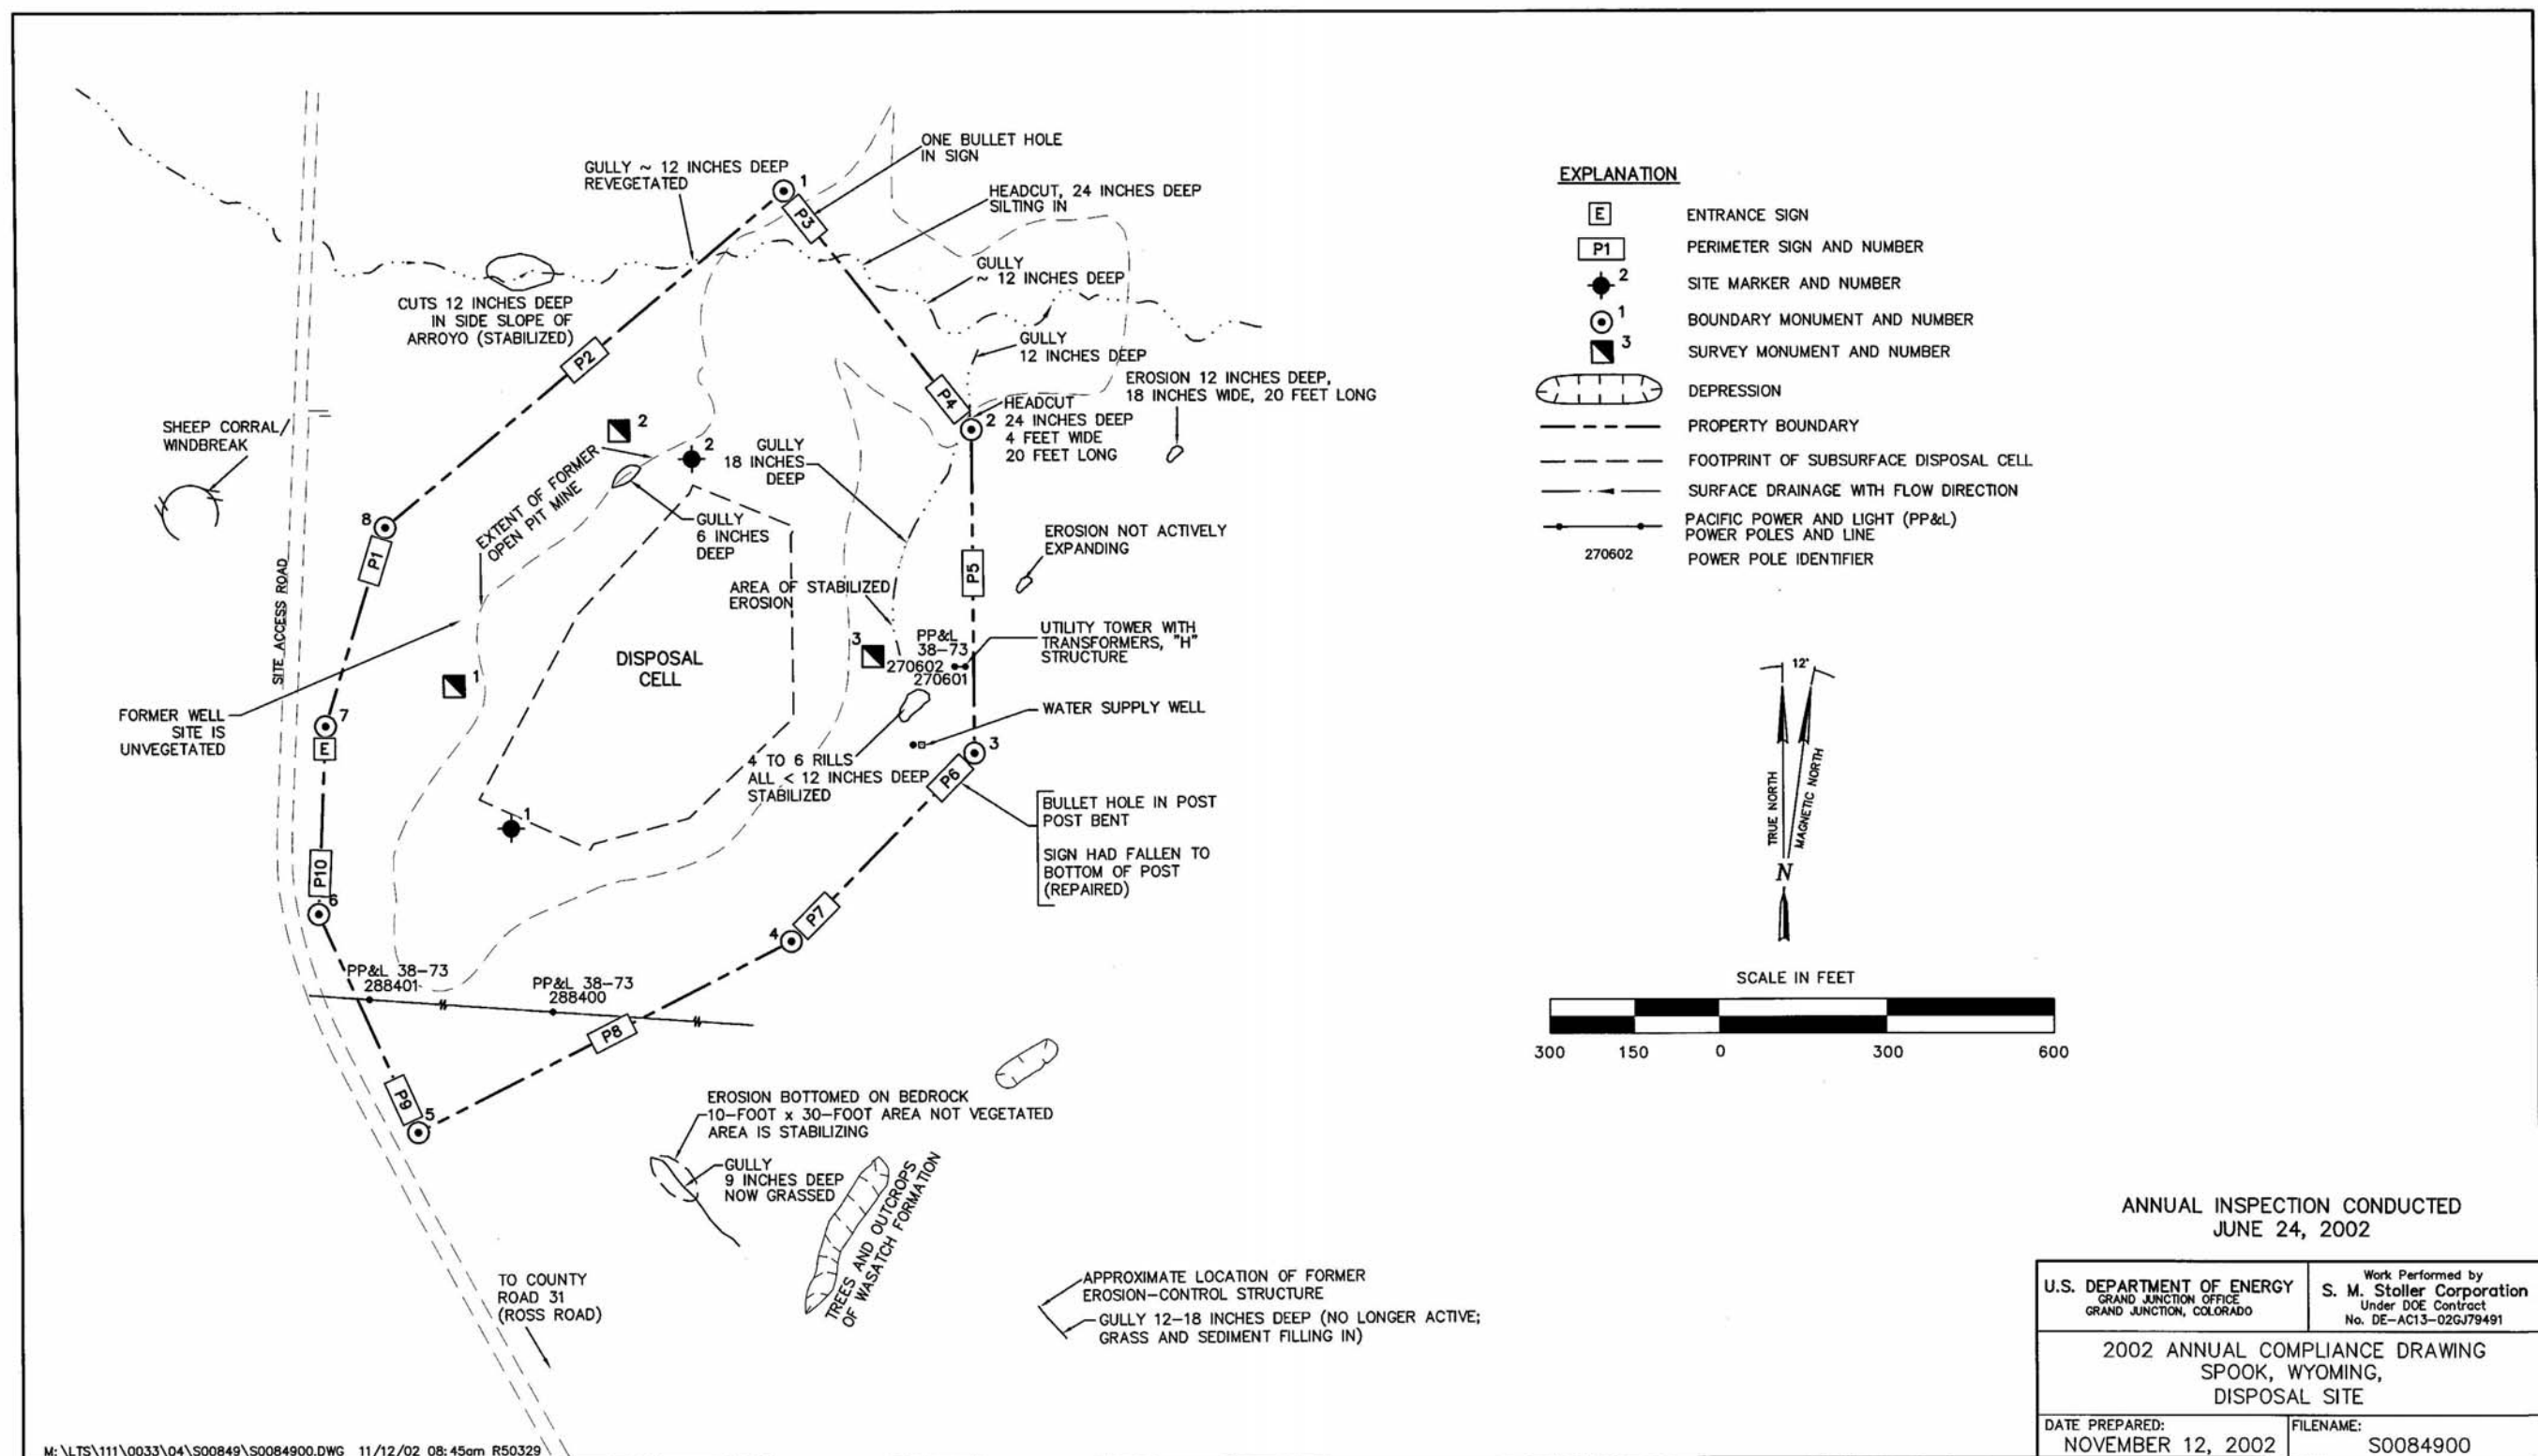
The site, in north central Converse County, Wyoming, was inspected on June 24, 2002. Results of the inspection are described below. Features mentioned in this report are shown on Figure 18–1. The number in the left margin of this report refers to an item summarized in the Executive Summary table.

Although there is a wire gate in the stock fence along the access road, the site itself is open range (unfenced). The site has one entrance sign and 10 perimeter signs set on posts along the site boundary. Perimeter sign P3 had a bullet hole but was legible. The post for perimeter sign P6 was bent and had a bullet hole; its sign had fallen to the bottom of the post and was resecured by the inspectors. All other signs were in excellent condition.

Formerly active areas of erosion northeast and southeast of the site continue to be filling in with sediment and revegetating naturally. Erosion continues to occur in a gully near perimeter sign P4. This active location and formerly active areas will continue to be monitored.
